USDA-FOREST SERVICE

FS-2500-8 (7/08)
Date of Report: 1/16/18

DRAFT THOMAS BURNED AREA REPORT
(Reference FSH 2509.13)

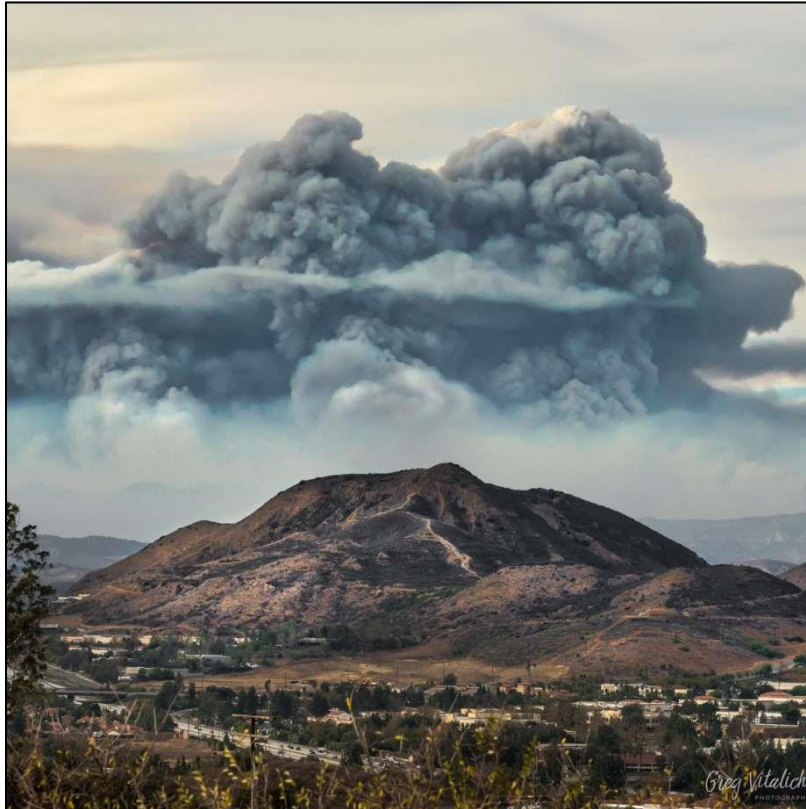
The Thomas Fire of 2017 looking at Santa Paula River drainage.

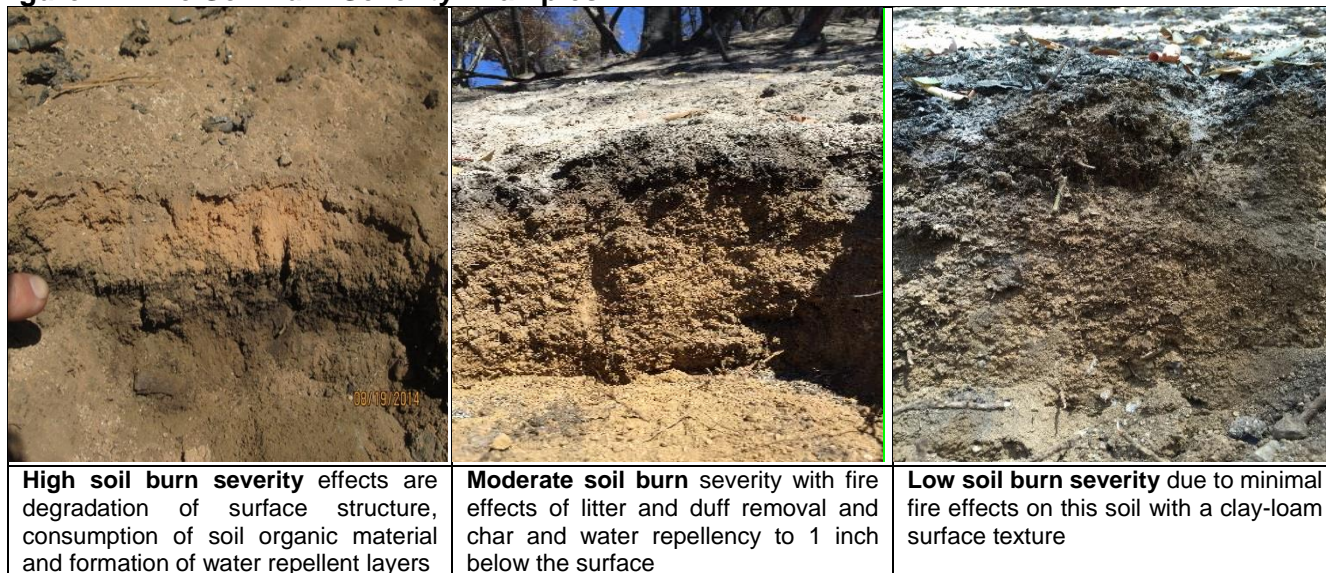
Figure 2 – Fire Soil Burn Severity Examples

The following pictures (Figures 2 & 3) are companion pictures to show typical soil burn severity and landscapes with mixed mortality due to differing vegetation types, slopes, aspect, and location.

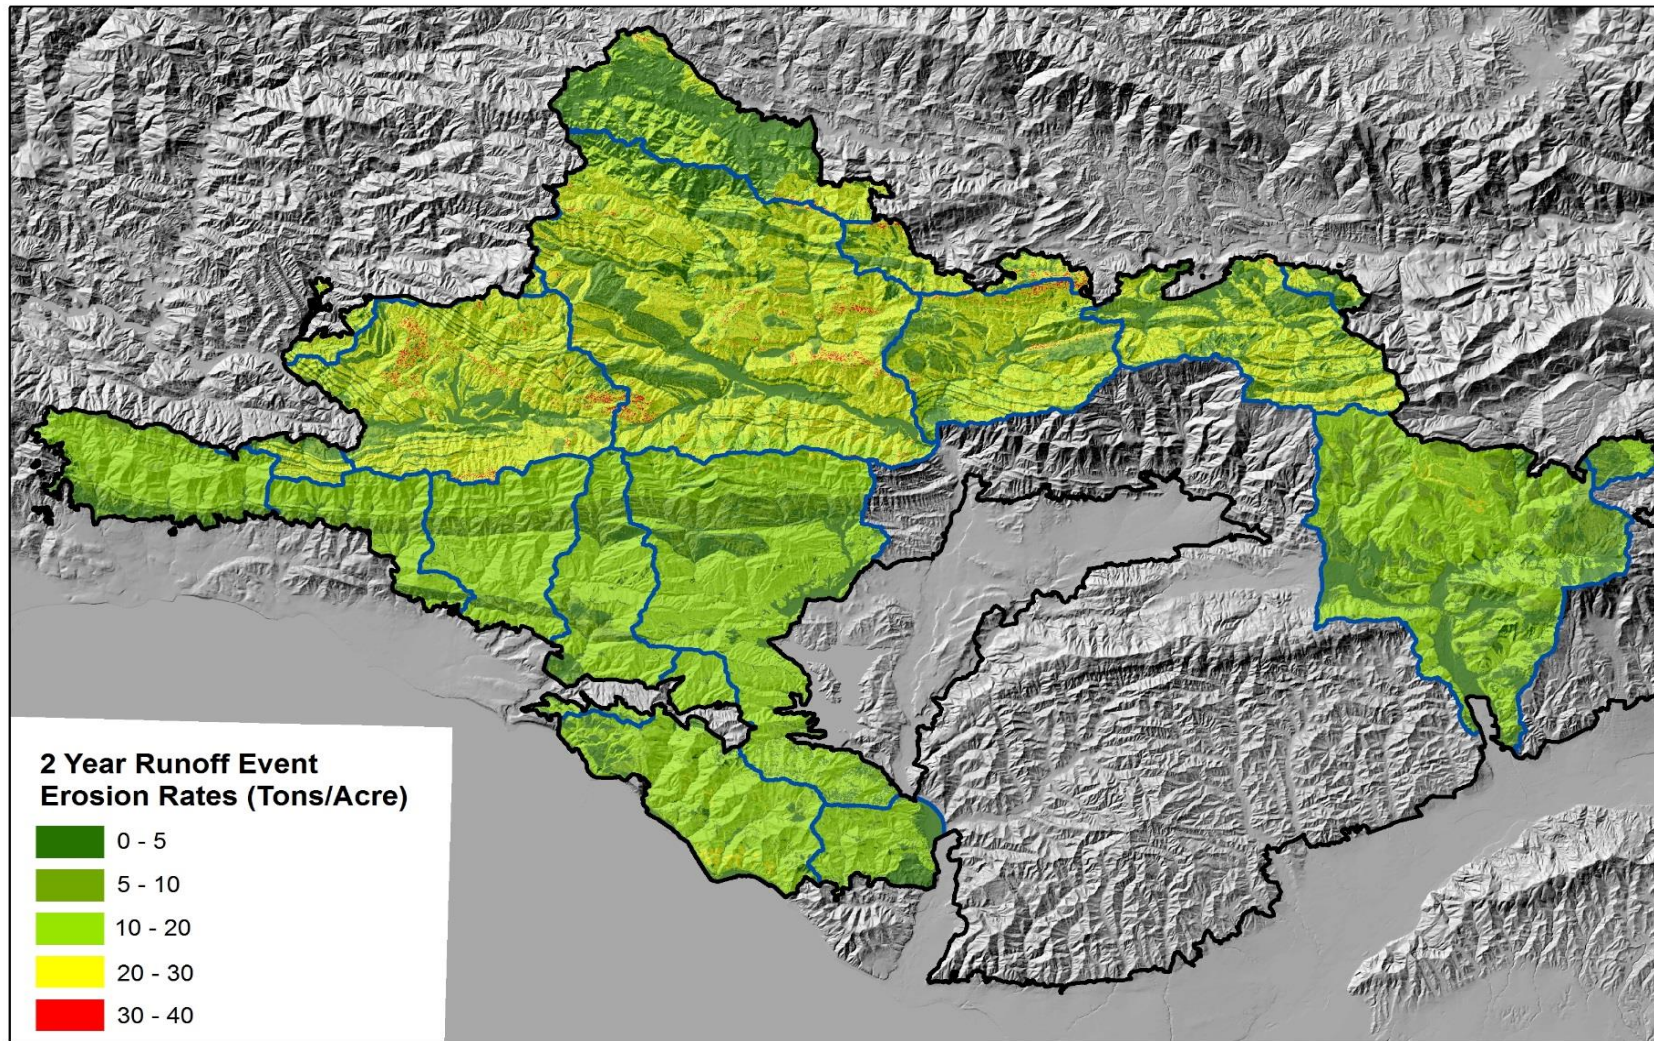
ERMiT Erosion Potential - 2 Year

The Erosion Risk Management Tool (ERMiT), was used to model both pre and post fire sedimentation. In areas with moderate and high burn severity, erosion potential was generally increased above natural conditions. Sedimentation was modeled for the first year post-fire with 2, 5, and 10 year runoff events.

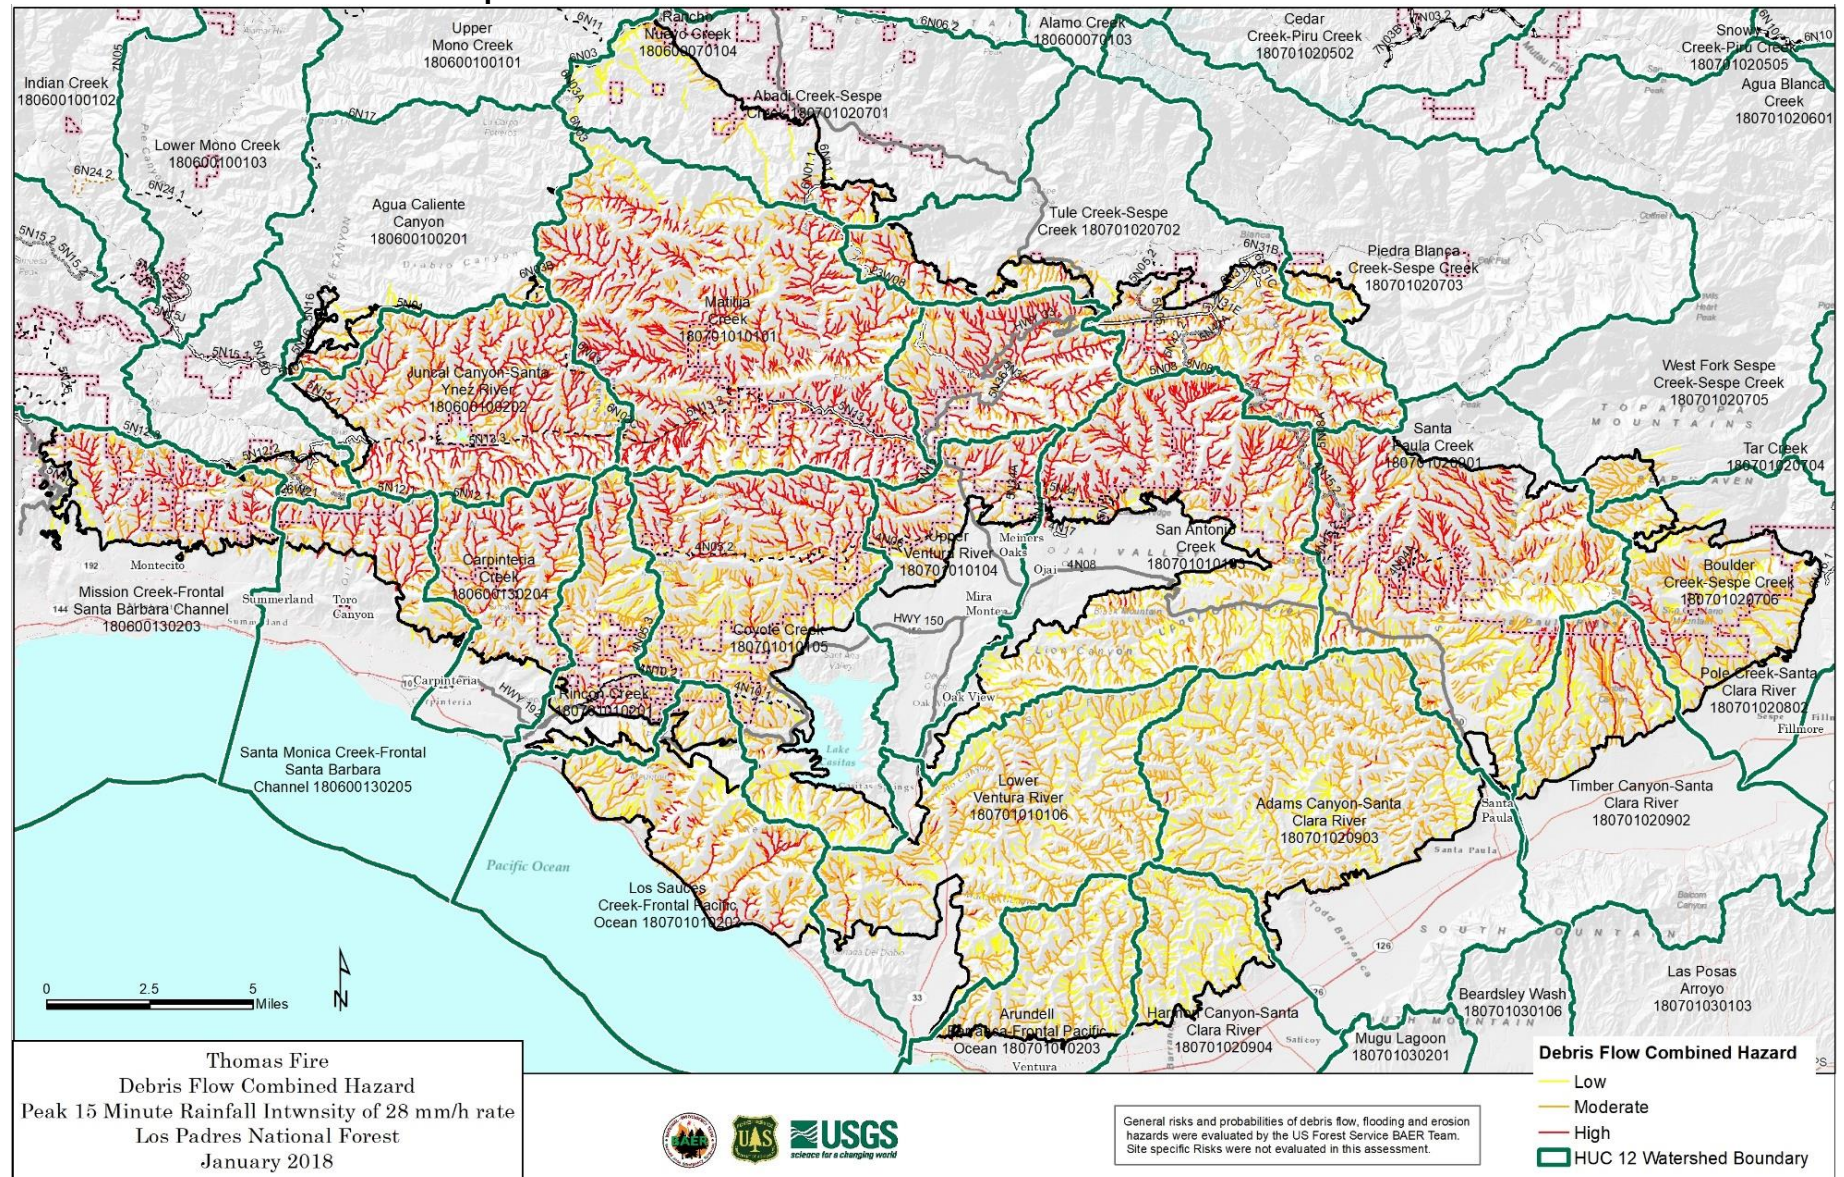
Debris Flow Combined Hazard Map for the Thomas Fire

Based on USGS debris flow modeling it appears that under conditions of a peak 15-minute rainfall intensity storm of 28 millimeters per hour (1.1 inch/hr.), the probability of debris flows occurring is 80-100% in the majority of the main channel/creeks in the burn area. Under these same conditions, predicted volumes of these debris flows are expected to range from 10K-100K cubic meters in these same channels. From the debris flow combined hazard map it appears that the majority of creeks in the burn area are predicted to produce debris flows of a high combine hazard (see Appendix B for map).
